*SPECIAL SERVICES INVESTIGATION  
INVOLVING WATER ADDITIVES THROUGH  
SPRINKLERS TO EVALUATE THE  
PROTECTION OF RUBBER TIRES*

*Prepared by  
Underwriters Laboratories Inc.  
Project 02NK41689, NC4432  
for  
MICHELIN TIRE  
April 30, 2003*

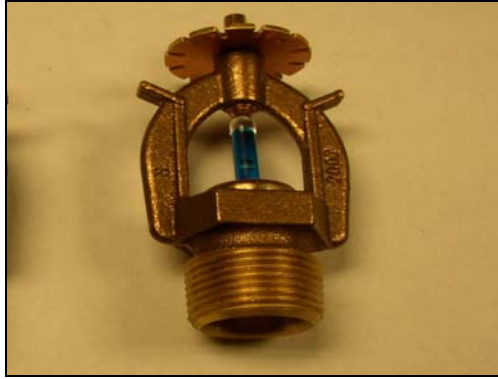
Figure 3. K=11.2 Pendent Sprinkler

A close-up photo of the sprinkler is shown in Figure 3.

One hundred pendent sprinklers were positioned on a 10 by 10-ft spacing. The sprinklers had a flow coefficient (k) equal to  $11.2 \text{ gpm}/(\text{psi})^{1/2}$ . The sprinkler temperature rating was 286°F with a standard response element. The deflector was positioned 13-in. below the ceiling.

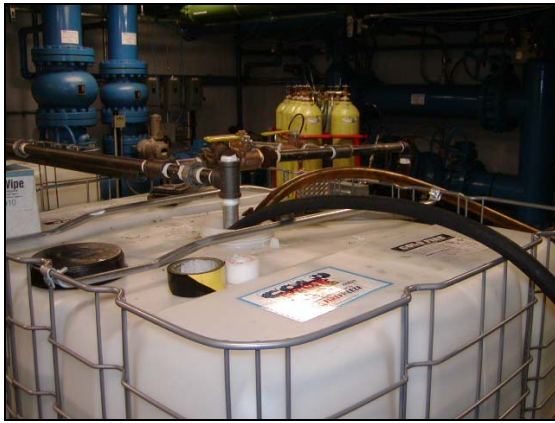
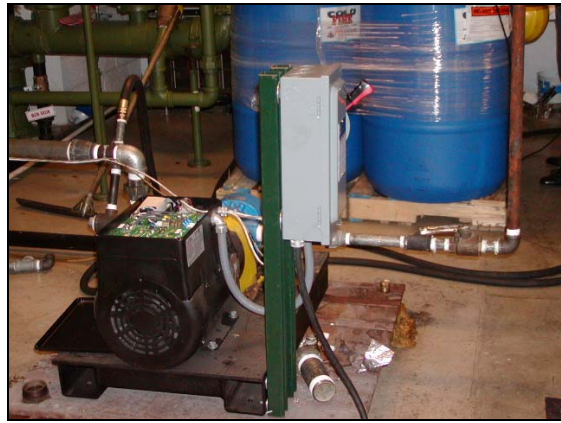
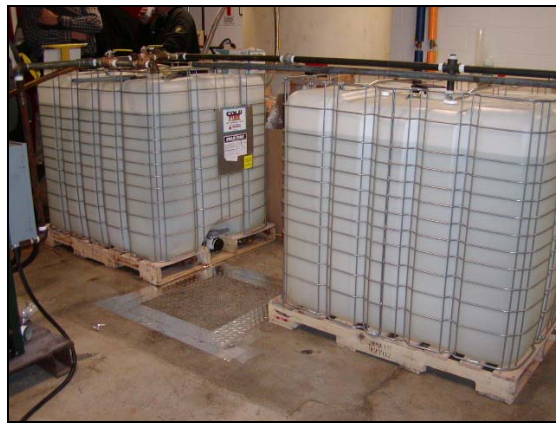
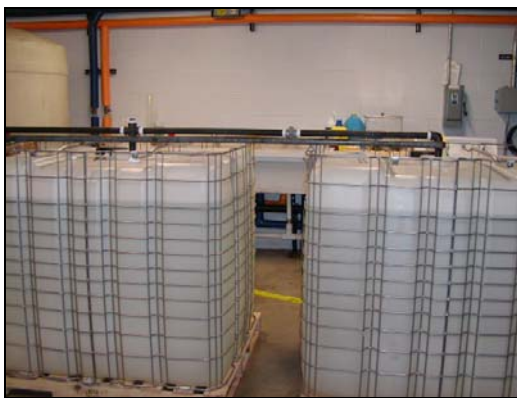
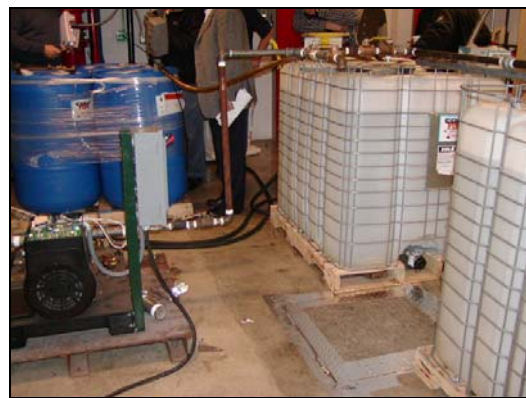
Figure 4. Pump Set-Up

Photos of the pump set-up are shown in Figure 4.

- Bristol Babcock Model 250815B pressure transducers in a 0-300 psi range were used to measure the water pressure in the sprinkler system.
- Fischer Porter model X3311SFD20 – 12 inch magnetic flow meter in the 0-3200 gallons per minute (gpm) range were used to measure the water flow rate.

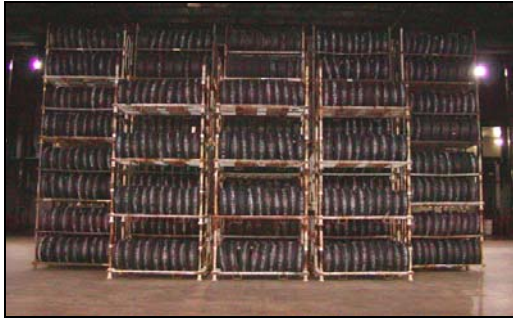
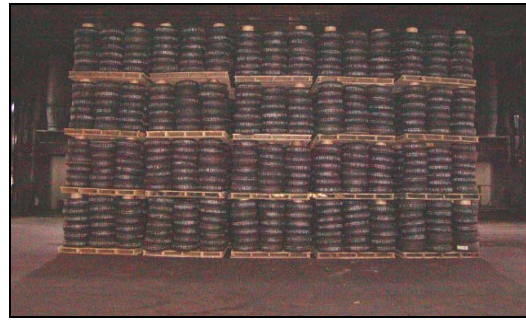
Figure 5. Rubber Tire Storage Arrangement

RUBBER TIRES – The sample consisted of rubber tires stored on tread or sidewall. Each pallet was a nominal 60-in. tall. Samples are shown in Figure 5.

On Tread

On Sidewall

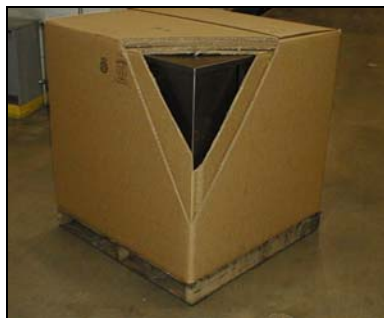
Figure 6. Standard Class II Commodity

CLASS II – The Class 2 commodity was constructed from double tri-wall corrugated cardboard cartons with five sided steel stiffeners inserted for stability. Outer carton measurements were 42 by 42 by 42-in. tall on a single 42 by 42 by 5-in. tall hardwood two-way entry pallet. A sample is shown in Figure 6.

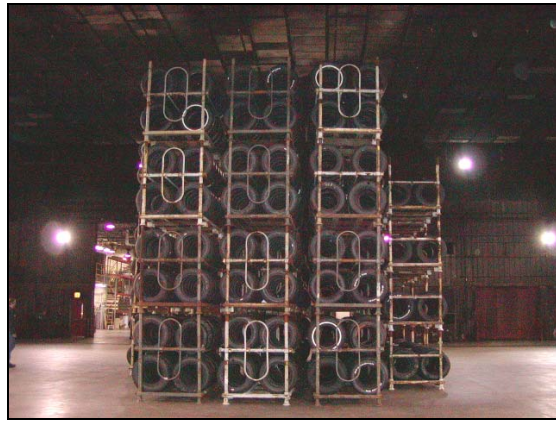
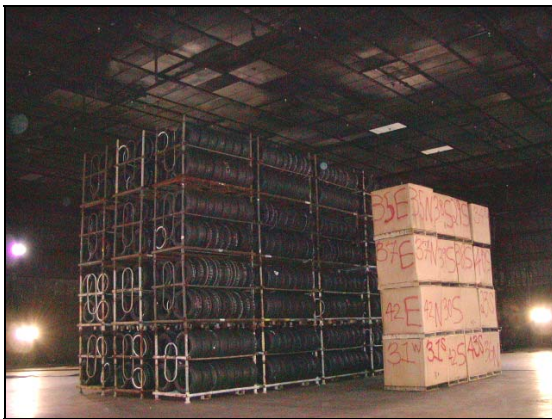
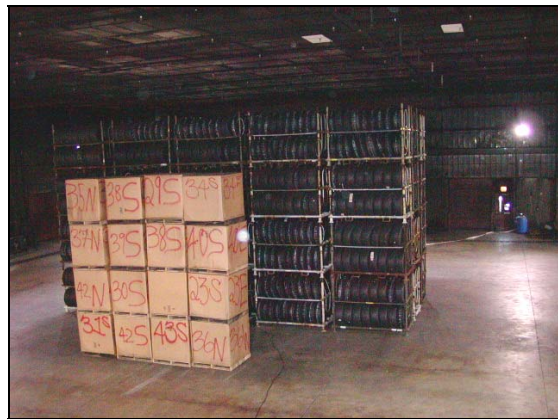
Figure 8. Test 1 Set-Up

The first fire test was conducted with 18 stacks of palletized rubber tires, with each stack containing 4 pallets. A six-in. flue space separated the stacks. The tires were stored on the tread with 36 tires per pallet. The test layout is presented in Figure 7. The storage arrangement will contain 2592 tires and 72 portable racks.

Photos of the arrangement are shown in Figure 8. The fire test and posttest damage photos are presented in Figure 9 and Figure 10 respectively.

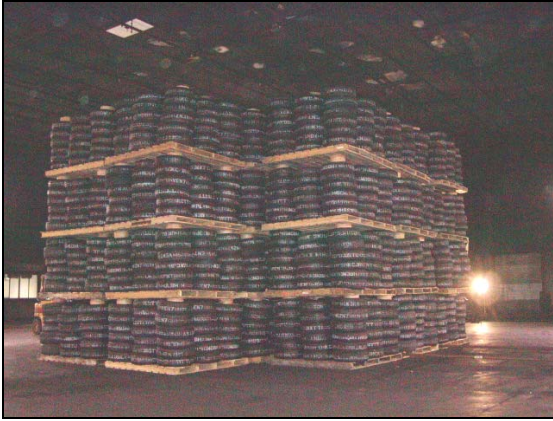
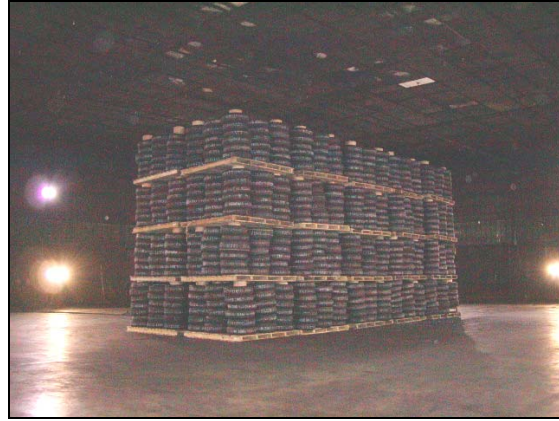
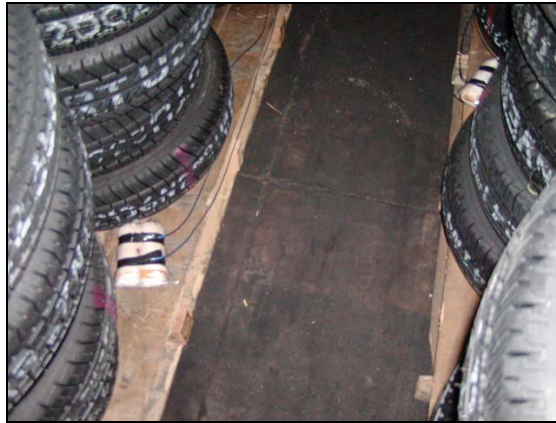
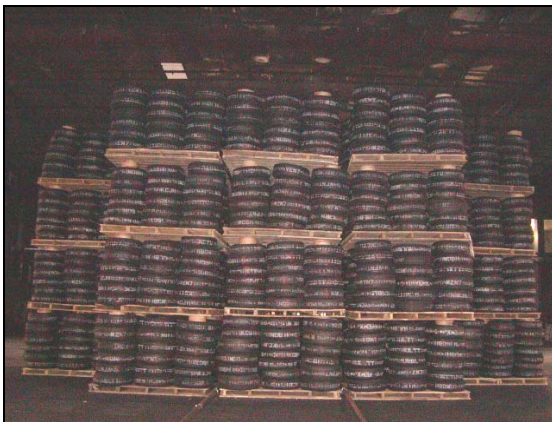
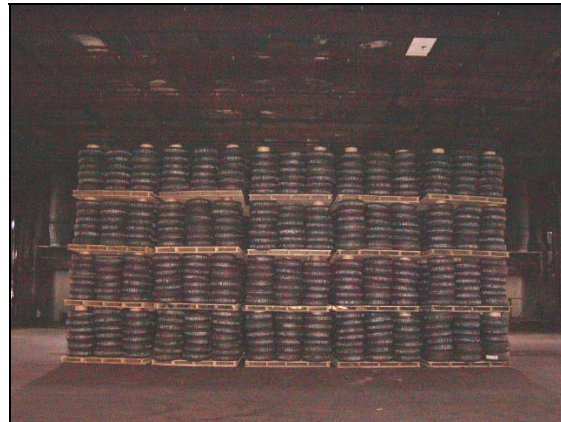
Figure 13. Test 2 Set-Up

The second fire test was conducted with 13 stacks of palletized rubber tires, with each stack containing 4 pallets. A six-in. flue space separated the stacks. The tires were stored on the tread with 63 tires per pallet. The test layout is presented in Figure 12. The storage arrangement contained 3276 tires and 52 portable racks.

Photos of the arrangement are shown in Figure 13. The fire test photos and posttest damage photos are presented in Figure 14 and Figure 15 respectively.

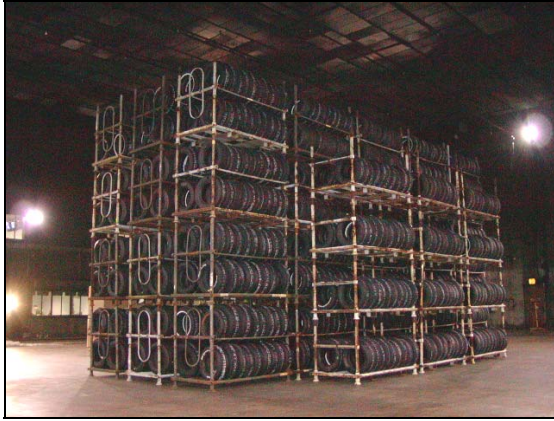
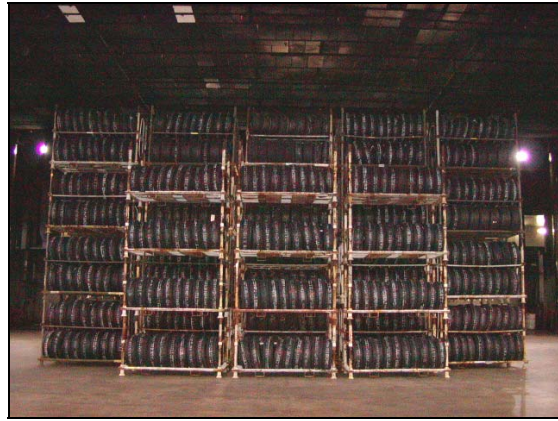
Figure 18. Test 3 Set-Up

The third fire test was conducted with 18 stacks of palletized rubber tires, with each stack containing 4 pallets. A six-in. flue space separated the stacks. The tires were stored on the tread with 36 tires per pallet. The test layout is presented in Figure 17 and is identical to that of Test 1. The storage arrangement will contain 2592 tires and 72 portable racks.

Photos of the arrangement are shown in Figure 18. The fire test and posttest damage photos are presented in Figure 19 and Figure 20 respectively.
